Inspection Report
Minerals Regulatory Program
May 22, 2008

Mine Name: Redd Block IV
Operator Name: Denison Mines

Permit number: M0370046
Inspection Date: April 30, 2008
Time: 1:30-2:00 PM

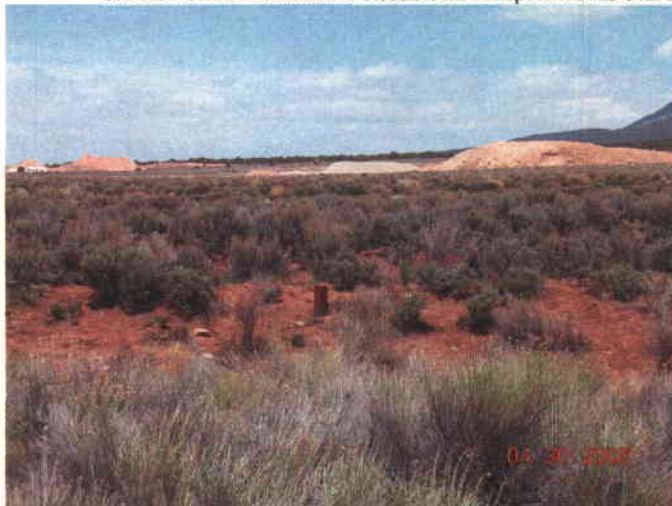
The site consists of two empty water treatment ponds, a flattened area with a concrete pad, an opened cased hole (water monitoring well?) next to the pad, and some power poles with Utah Power labels. This mine has never been opened. I dropped a few rocks in the cased hole, and it took about eight seconds for them to hit the bottom. I did not hear a splash.

Photo 1. This appears to be a water monitoring well, but it was not capped.

The drill hole should be capped.

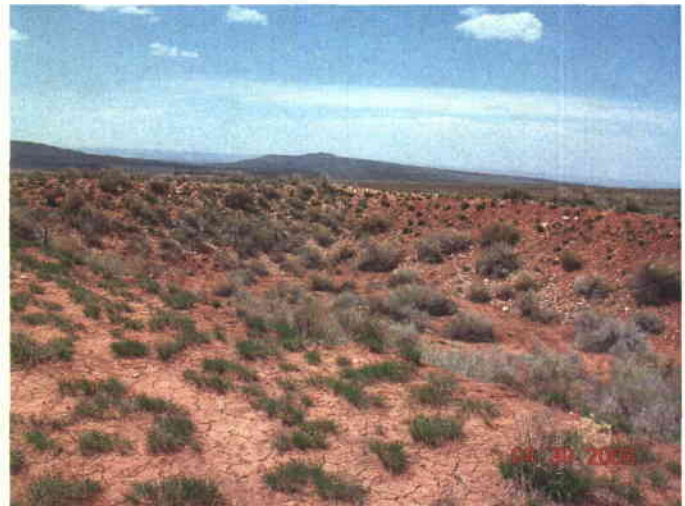
Photo 3. This is one of the ponds.

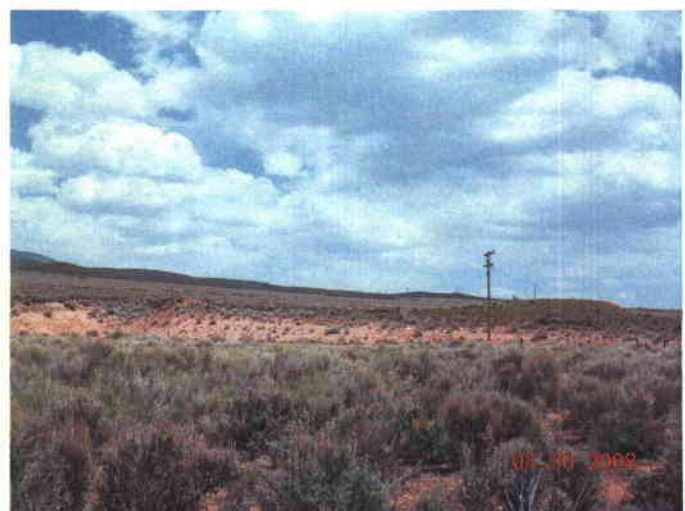
Photo 4. An overview of the area where the concrete pad is located.
